# ANSLEY WILCOX HOUSE

## HISTORIC STRUCTURE REPORT

Theodore Roosevelt Inaugural  
National Historic Site  
Buffalo, New York

October 2006

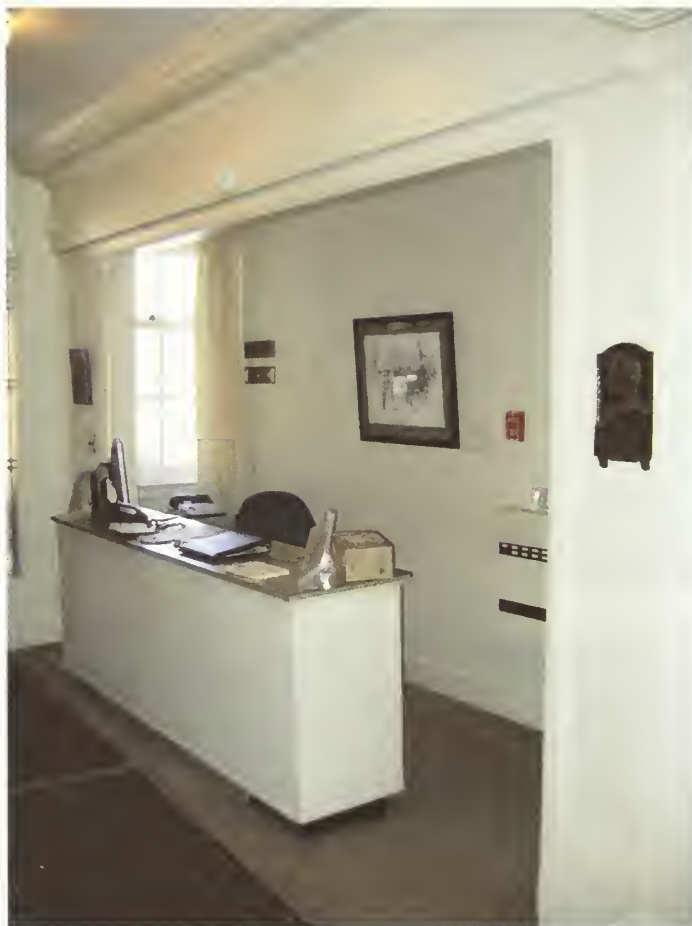
Figure 2.38 Room 106 (Side Hall), former location of missing east wall.

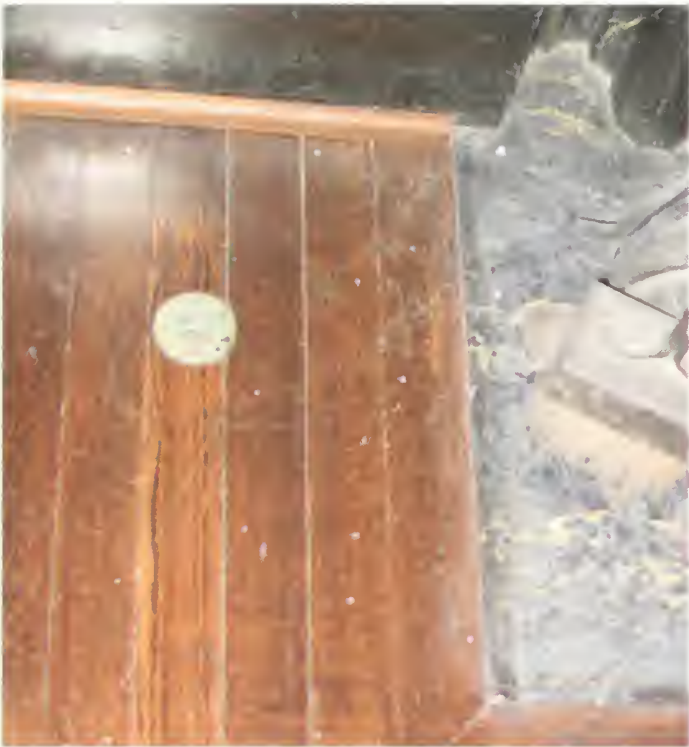
Figure 2.39. Room 107 (Living Room), unidentified floor feature.

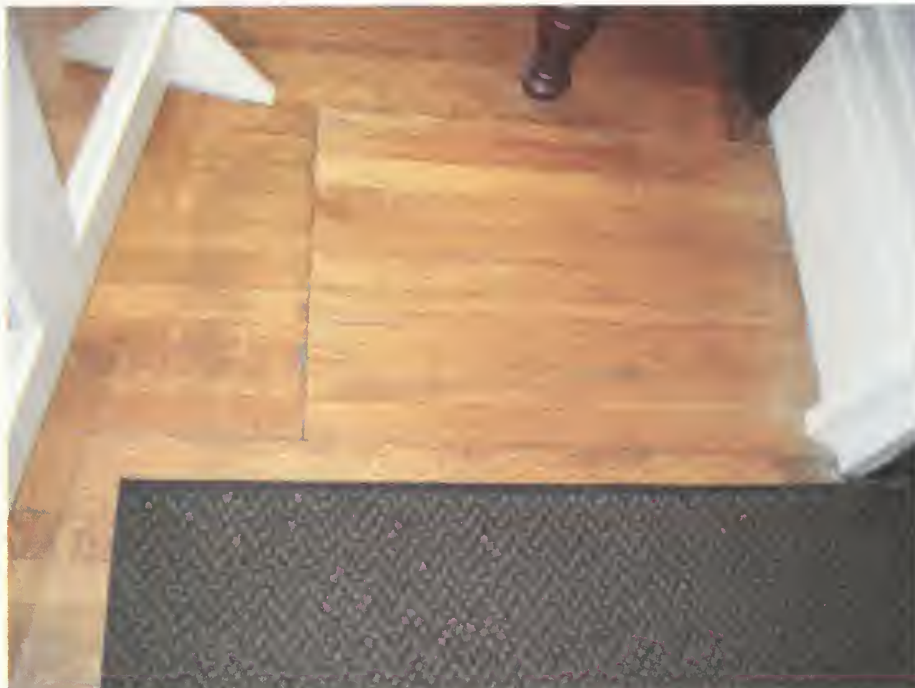
Figure 2.43. Room 108 (Dining Room), former location of missing floor register.

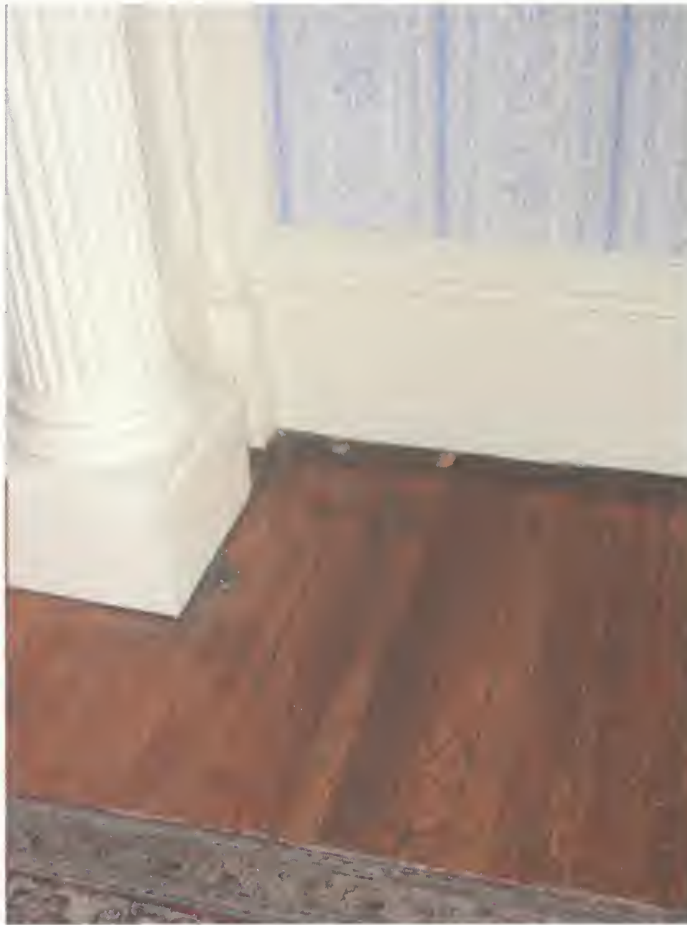
Figure 2.44. Room 108 (Dining Room), unidentified floor feature.

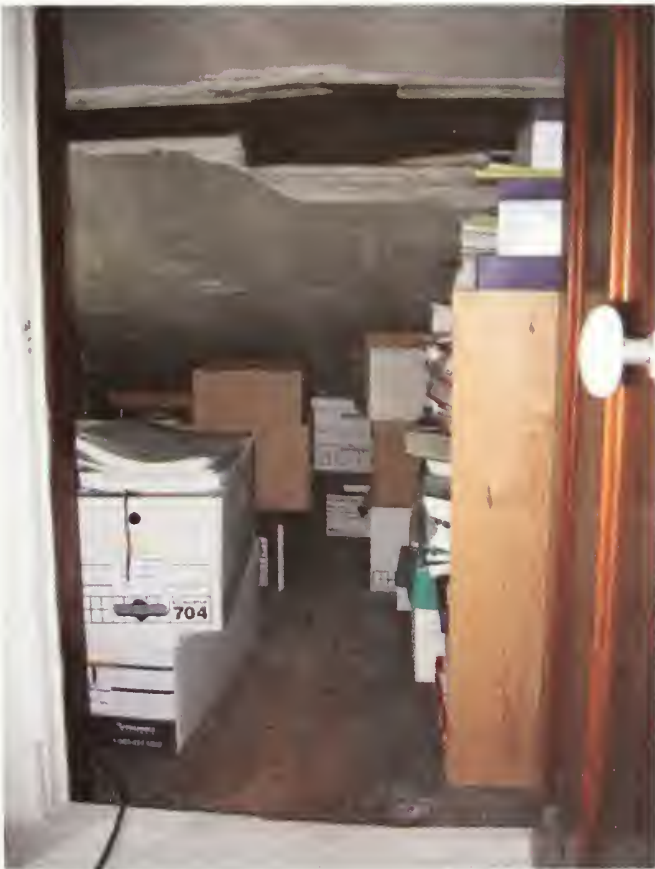
Figure 2.79. Room 305a,  
deteriorated plaster ceiling.
